MANDATORY
SERVICE BULLETIN

No. 0010

SUBJECT: Mercedes DIII Piston Rings, Part no W2M1802-0013.

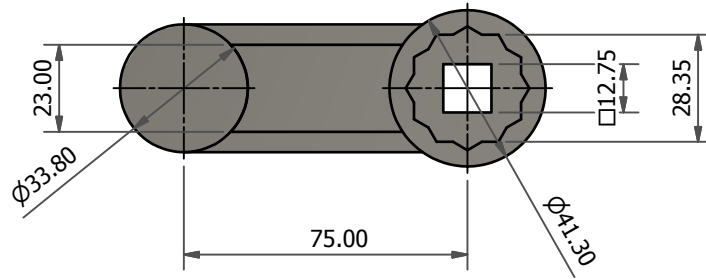
TOP VIEW

NOTE 1: DIMENSIONS ARE APPROX. USE THE CORRECT SPANNER SIZE AND ALIGN TO TORQUE WRENCH SQUARE.

(Note; Special tool is required to be made, drawing of which is attached to this Bulletin for local manufacture)

7. Remove ring nut from rear cylinder water inlet pipe and remove bleed pipe from top of cylinder.
8. Using special tool made to the drawing with this bulletin, remove all cylinder holding nuts and bridges.
